**FEDERAL AVIATION ADMINISTRATION
AIRWORTHINESS DIRECTIVES
LARGE AIRCRAFT**

BIWEEKLY 2004-01

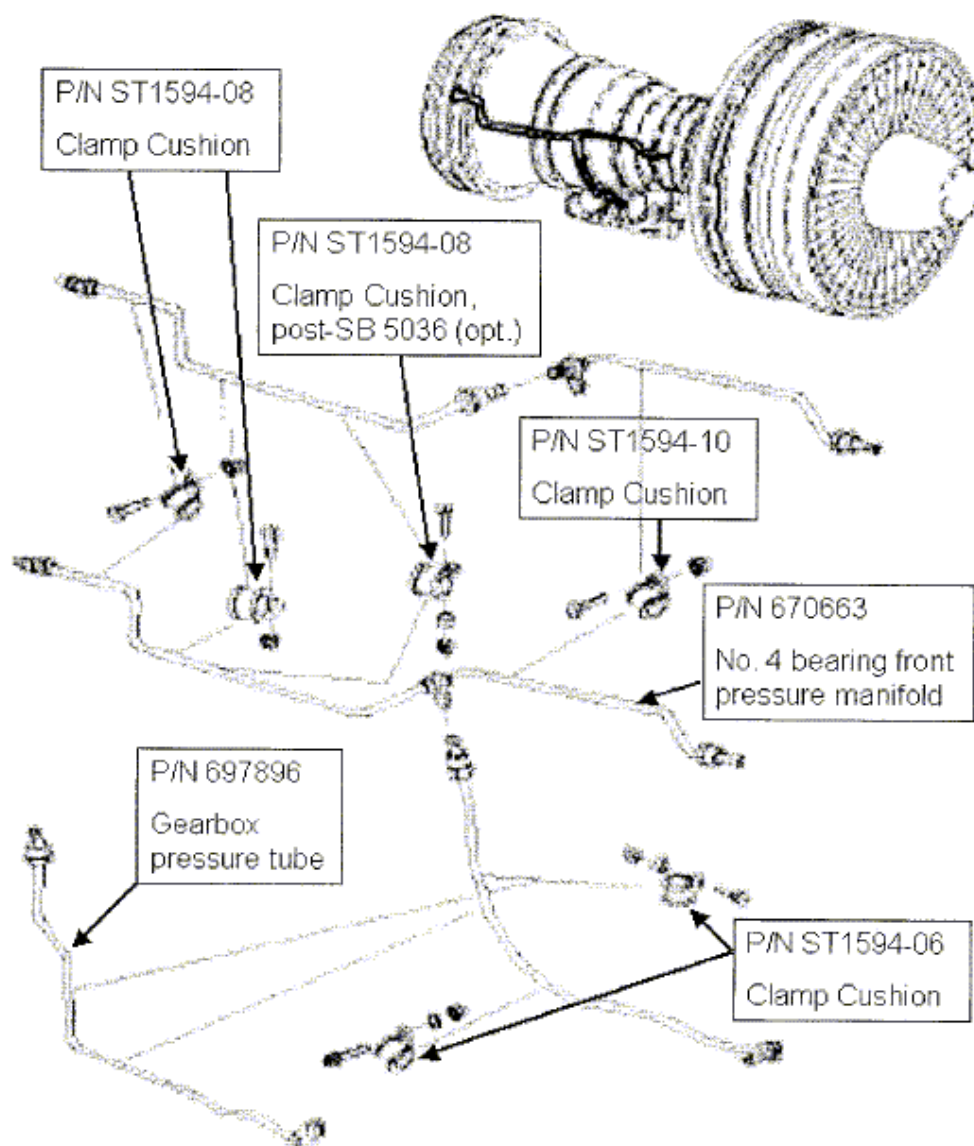
(f) Visually inspect the clamp assemblies, P/Ns ST1594-06, ST1594-08, and ST1594-10, (see Figure 1 of this AD) that attach the gearbox pressure tube and the No. 4 bearing front pressure manifold to the engine. Replace clamp assemblies before further flight that are rejected by any of the following rejection criteria:

- (1) Cracks, wear, or distortion in clamp metal.
- (2) Clamp cushions that are worn, compacted, cracked, coming apart in chunks, deteriorated, or missing. A reddish powder found around the clamp is an indication of deterioration.

Visual Inspection of Gearbox Pressure Tube and No. 4 Bearing Front Pressure Manifold

(g) If one or more clamp assemblies are rejected as described in paragraph (f) of this AD, or out of position or missing (see Figure 1 of this AD), clean any debris and oil from the outer surface of the gearbox pressure tube and No. 4 bearing front pressure manifold and visually inspect the tube and manifold. Repair or replace the affected tube or manifold before further flight if it is rejected by any of the following rejection criteria:

- (1) Nicks, chafing, scratches, and or pitting 0.003 inch or greater in depth.
- (2) Dents within 0.25 inch of the ferrules or will not permit free passage of a ball having a minimum diameter of 80% of the tubing inner diameter.
- (3) Corrosion that is unable to be removed by a light polishing.
- (4) Tube or manifold is leaking oil.
- (5) As an option to the dent inspection method specified in paragraph (g)(2) of this AD, measure tube dent depth and use the following rejection criteria:
